# TECHNICAL BULLETIN

BULLETIN NO.:	TB06-002
DATE:	August 23, 2006
PAGE:	1 of 1

## REFERENCE: Defective Rubber Foot Pads, Silver Eagle Part#8808

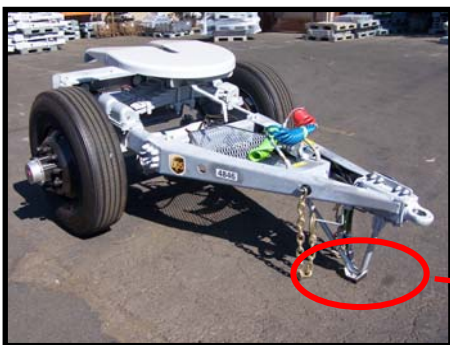
Photo #1

Please be aware it was recently discovered the adhesive used to secure the rubber foot pad to its mounting plate was incorrectly applied, resulting in foot pads detaching from their mountings. In some cases the pads are detaching while in transit to your facility.

If your facility has a strong, epoxy-style adhesive and the pad has been retained, the assembly can be repaired. However, Silver Eagle will replace all pads found to be defective at no charge. Please call

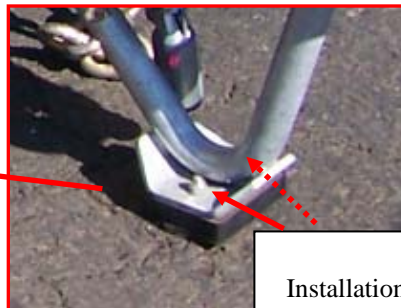
Photo #2

Installation

The pad is installed by removing the two screws securing it to the stiff leg base (see photo #2). Discard any remaining parts, and file a warranty claim for 15 minutes labor. Should you have any questions, please contact Silver Eagle directly at 1-800-547-6792 and ask for Karen Williams or Alyson Bennett. You may also call me directly at the numbers above.
