# TECHNICAL BULLETIN

BULLETIN NO.:	TB10-002
DATE:	January 8, 2010
PAGE:	1 of 1

**REFERENCE:** VA Dolly Boot Housing Bolt Change

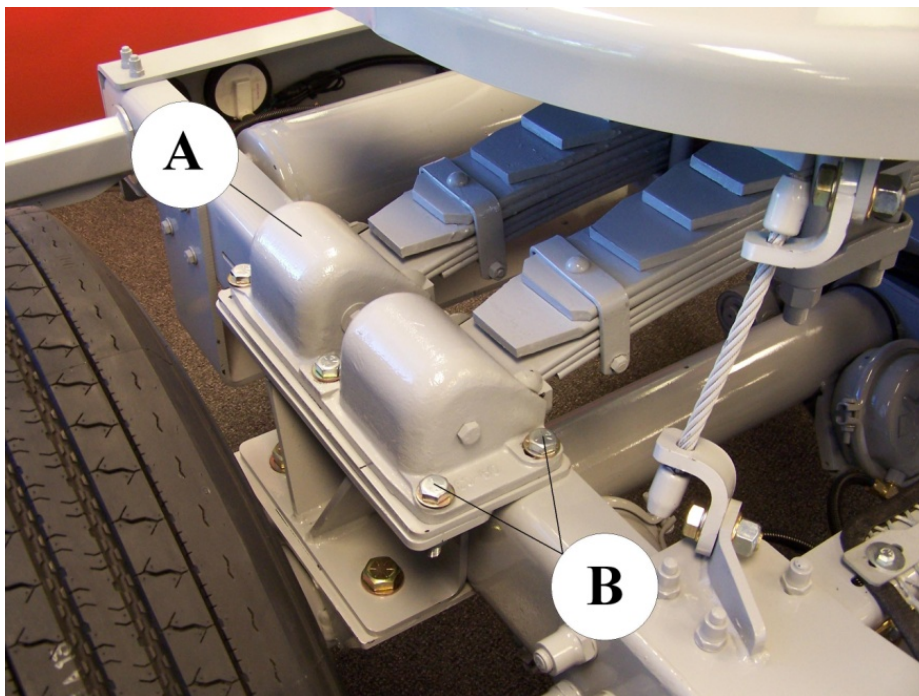
**CAUSE FOR ACTION:** In rare instances, the 5/8"-11 GR 5 capscrew used to attach the boot housings to the frame may break in service.

**Figure 1: Spring cap boot housing (A) and bolts (B) on a transverse leaf spring converter dolly (VAII shown)**

**SOLUTION:** Starting 9/09 the 5/8"-11 GR 5 capscrews were replaced with 5/8"-18 GR 8 capscrews with a new torque specification of 220 lb-ft  $\pm$ 10.

Any time boot housings are removed, they should be reassembled using new 5/8"-18 GR 8 capscrews (p/n 22429) and new 5/18"-18 GR C locknuts (p/n 8543). Use Loctite Marine Grade Anti-Seize on the threads during assembly.
